Subject : Minutes of meeting held on 25.05.2018 to discuss the issues of Frequent Operation of random power order change in HVDC Champa – Kurukshetra Pole-1 & 2 and unreliable operations of other West – North (WR-NR) inter-regional link

Minutes of the Meeting held to discuss the issues of Frequent Operation of random power order change in HVDC Champa – Kurukshetra Pole-1 & 2 and unreliable operations of other West – North (WR-NR) inter-regional link

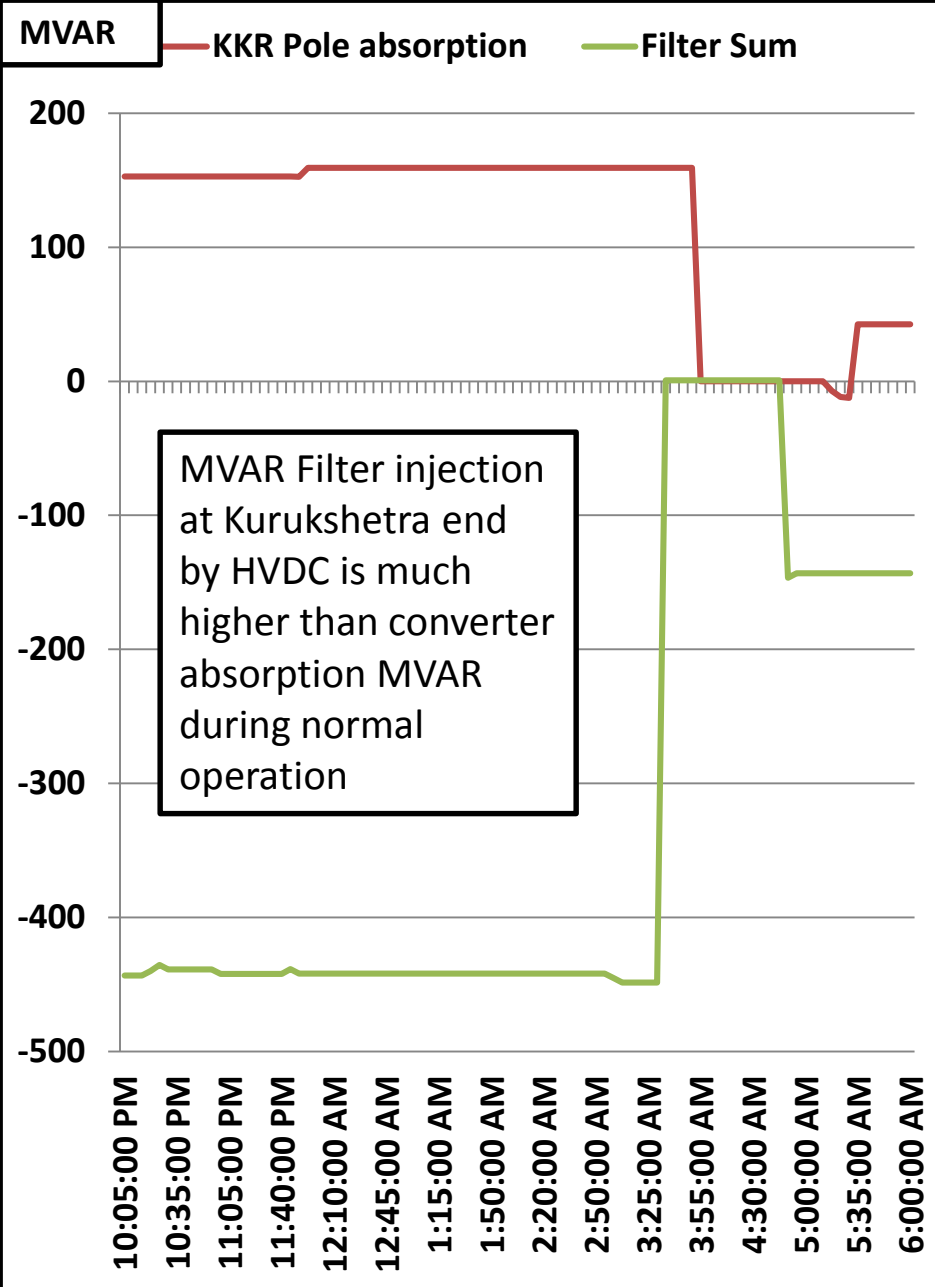
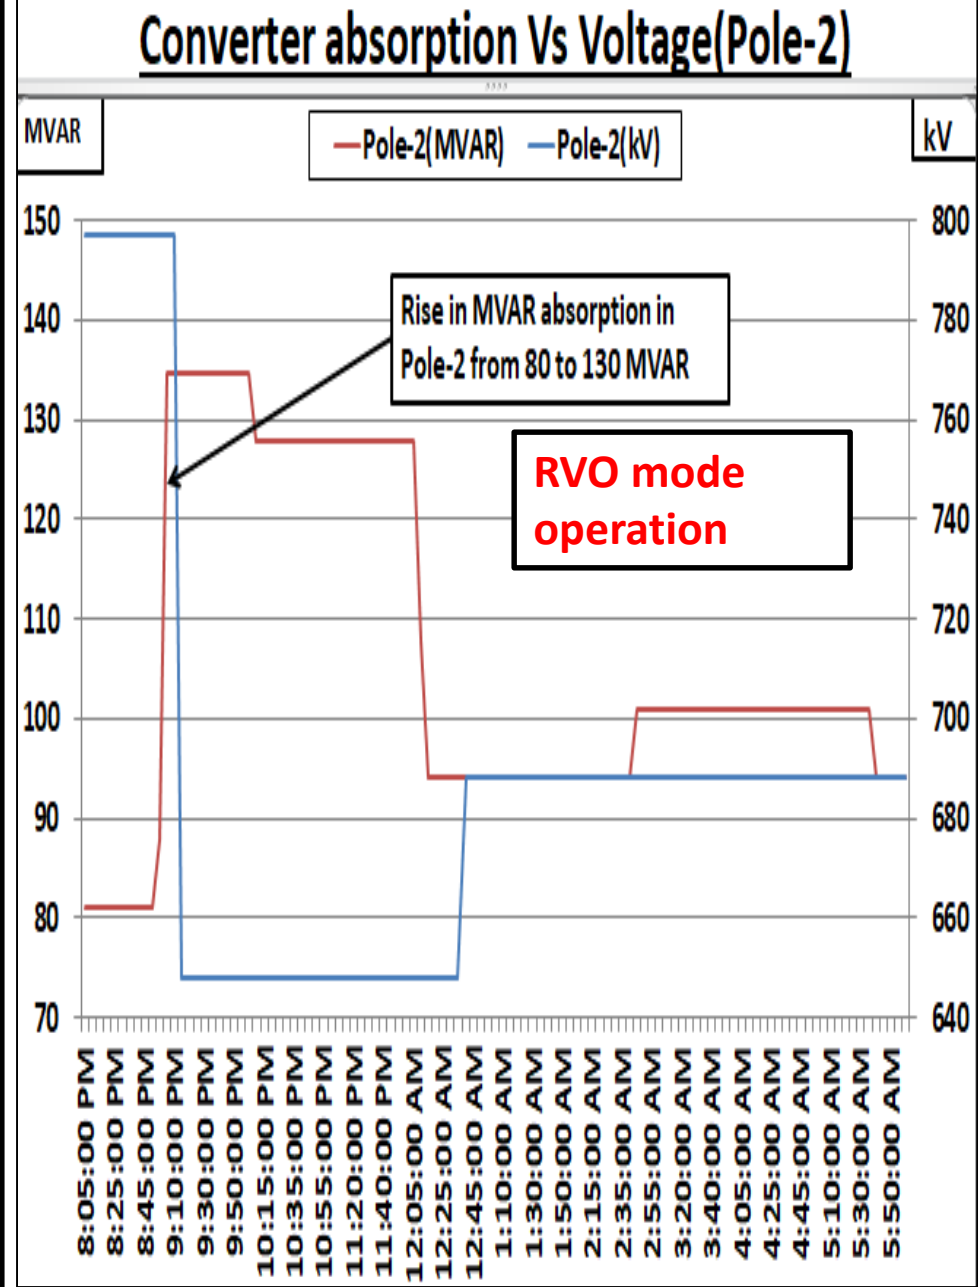
- It was found that in RVO mode, converters were observing more MVAR, a sample plot of such operation is given in next slide
- During RVO mode, site personnel informed that due to Gamma(extinction angle) limitations, pole can not be operated on RVO mode.

- In this regard it is requested that extinction angle and firing angle telemetry be provided from inverter and rectifier stations to RLDCs/NLDC

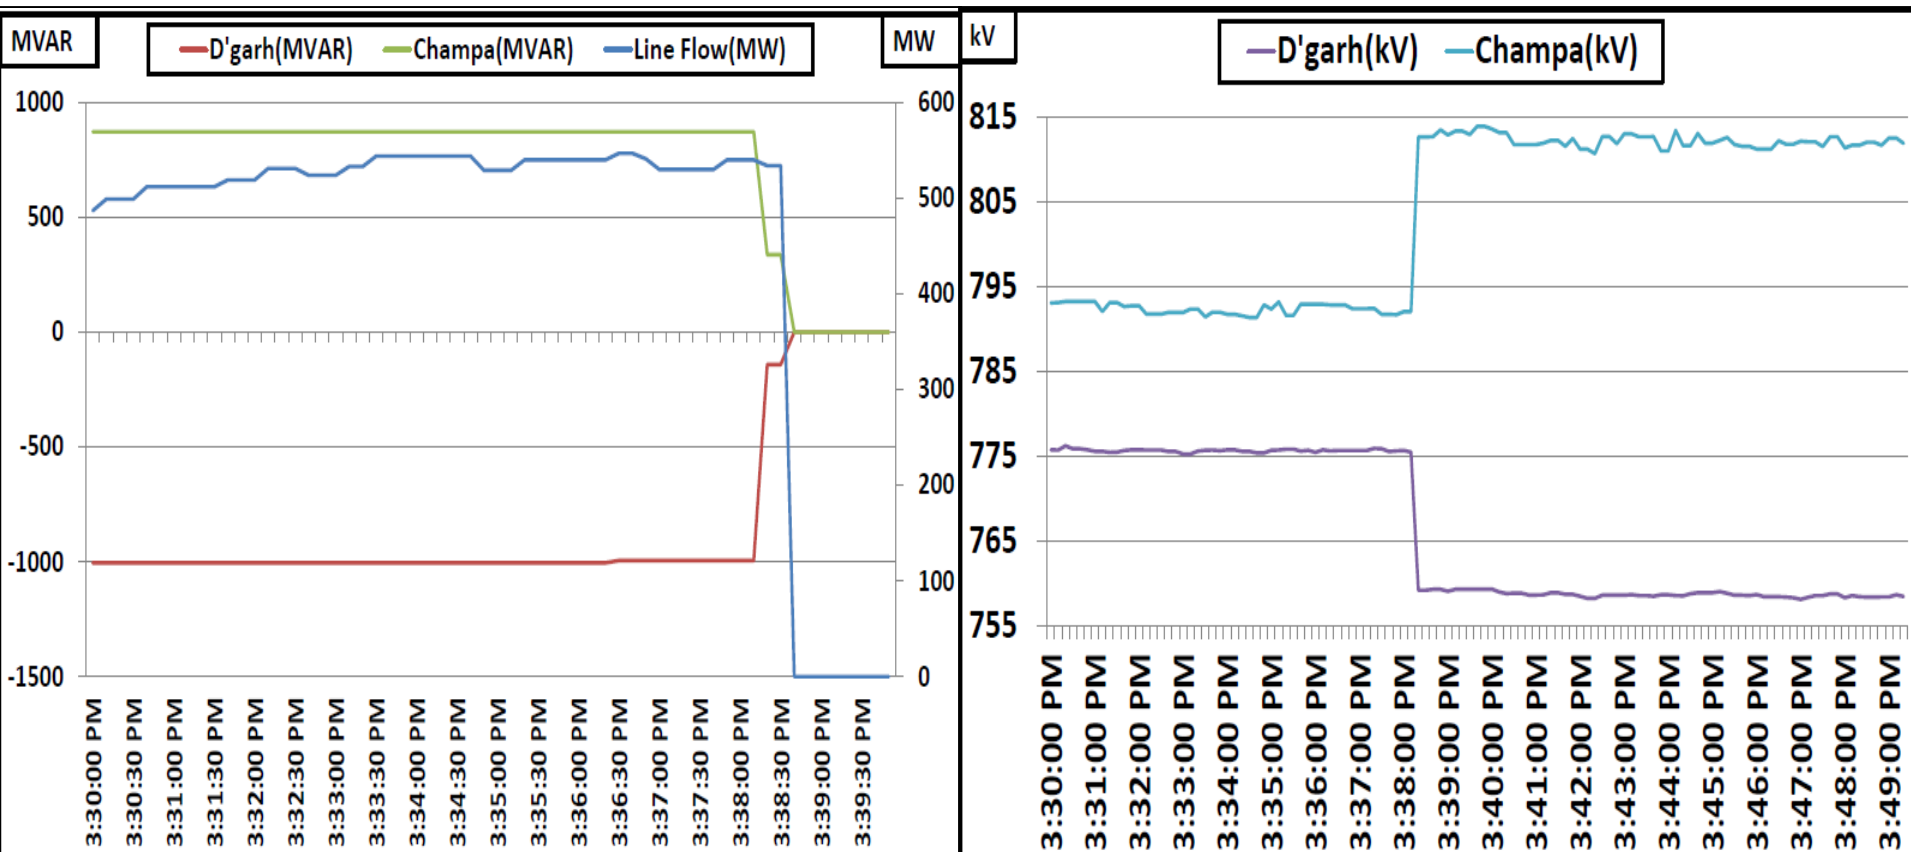
High Voltage problem at Champa

- In 765 kV Champa-Dharamjaigarh is observed that Champa end is injecting heavy reactive power into the line and during outage of line high voltage rise is observed. SCADA voltage and reactive power at both ends observed during one such incident given:

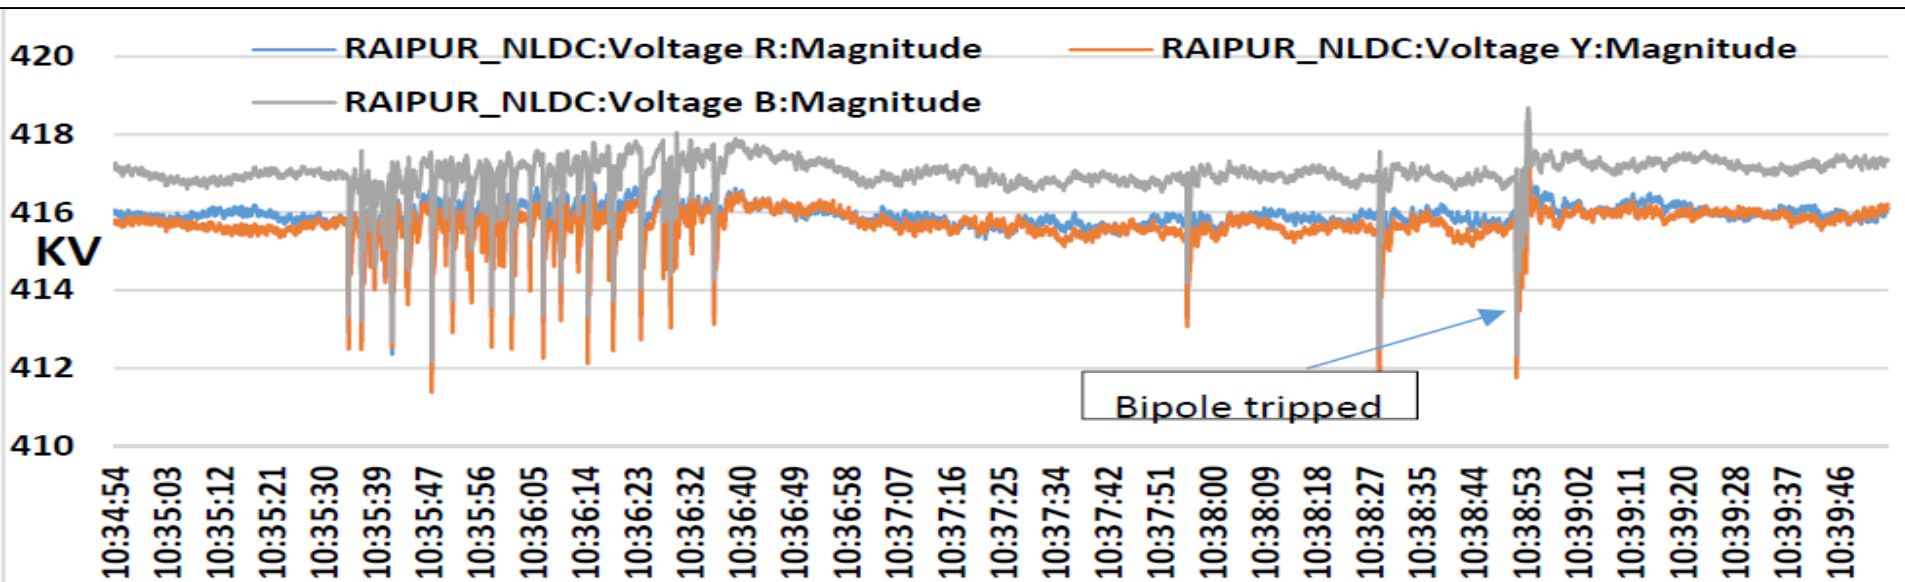
8. Commutation Failure :

- Pole-II has more cases of tripping on this account
- On 2nd Feb 2018, both poles tripped and resulted in oscillation, the PMU voltage plot is given below indicating 10-15 spikes before tripping
- The settings for commutation failure may be shared
